**Flood Control Project Maintenance
Levee Inspections**
LMA District Cover Sheet
Spring 2018 Levee Inspection Results

Butte County Department of Public Works

Unit Cover Sheet

Spring 2018 Levee Inspection Results

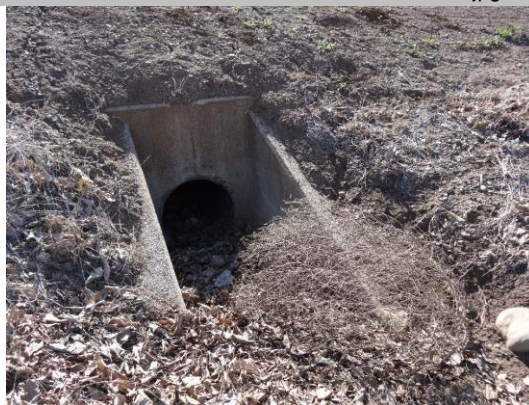
Photo 2 of 3 : UCIP_SP_2018_50142_55885.jpg

LS view: U type concrete headwall and CMP on levee slope. Vegetation debris blocking inlet.

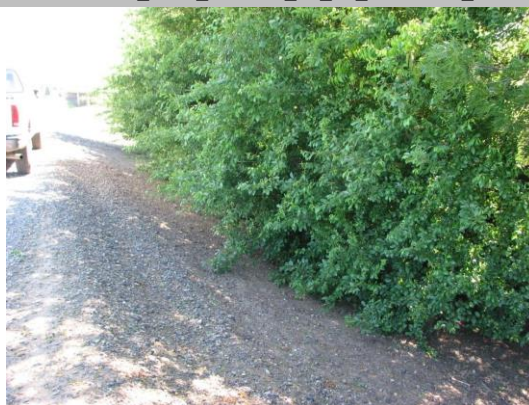
Photo 1 of 1 : SP_2018_NA0003_64_42_20180305_00024.jpg

View of the overgrown trees at the landside levee toe.

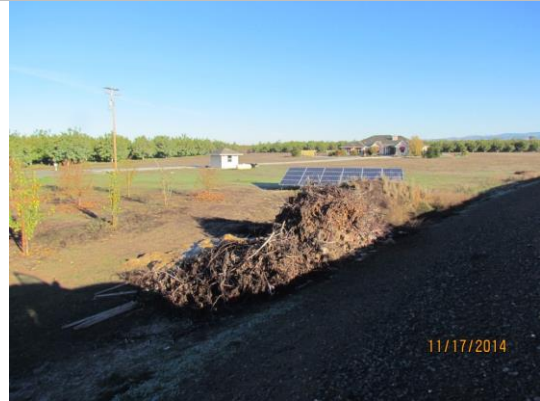
Photo 1 of 1 : SP_2018_NA0003_64_27_20180305_00009.jpg

View of the prunings along the landside toe.

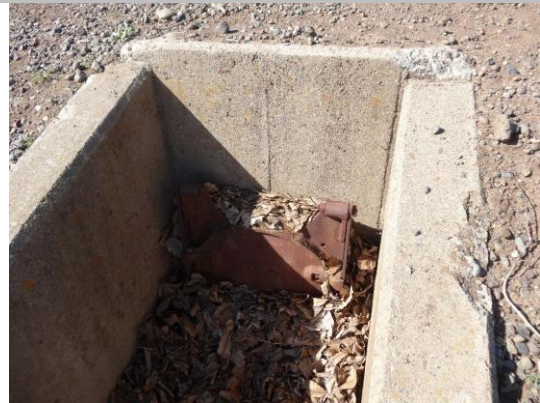
Photo 1 of 3 : UCIP_SP_2018_30310_55741.jpg

WS view: U type concrete headwall, pipe, and flapgate on levee slope.
Vegetation debris blocking outlet.

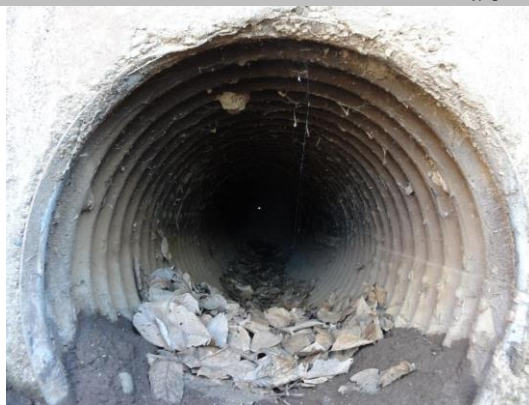
Photo 3 of 3 : UCIP_SP_2018_30310_55739.jpg

LS view: inside view of CMP on levee slope. Needs cleaning and clearing.

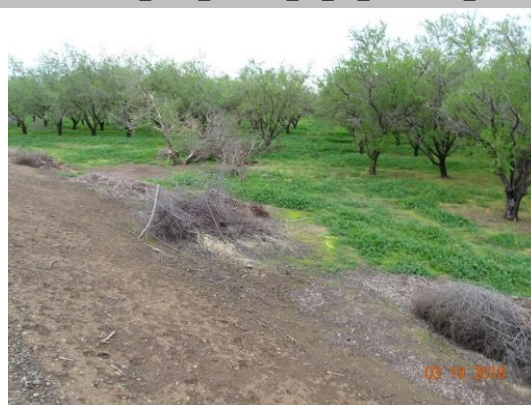
Photo 1 of 1 : SP_2018_NA0003_64_32_20180402_00067.jpg

View of the prunings along the landside toe.

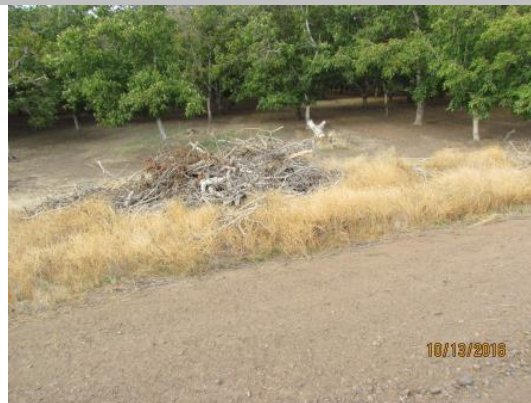
Photo 1 of 1 : SP_2018_NA0003_64_52_20180305_00031.jpg

View of the prunings along the landside toe.

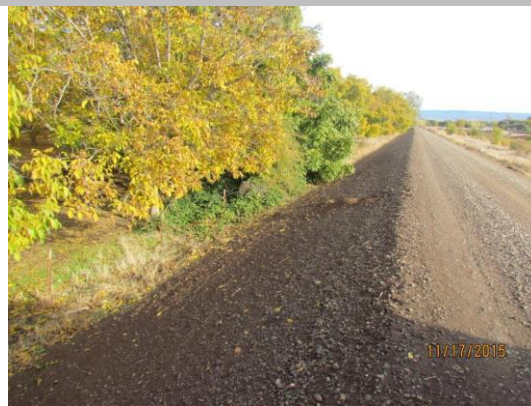
Photo 1 of 1 : SP_2018_NA0003_64_33_20180305_00015.jpg

View of the rodent holes along the landside slope.

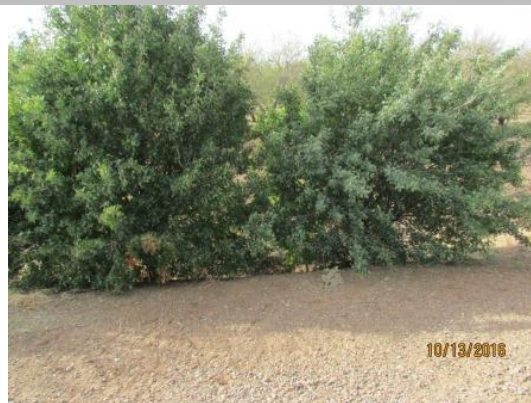
Photo 1 of 1 : SP_2018_NA0003_64_53_20180305_00032.jpg

View of the trees along the landside toe.

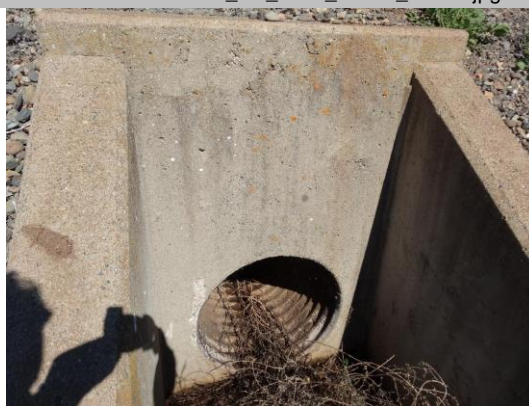
Photo 3 of 3 : UCIP_SP_2018_31667_57966.jpg

LS view: U type concrete headwall and CMP on levee slope. Vegetation debris on inlet box.

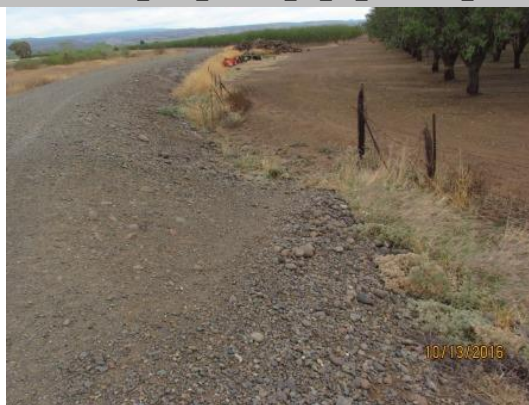
Photo 1 of 1 : SP_2018_NA0003_65_29_20180305_00008.jpg

View of the slope instability caused by vehicles along the landside slope.

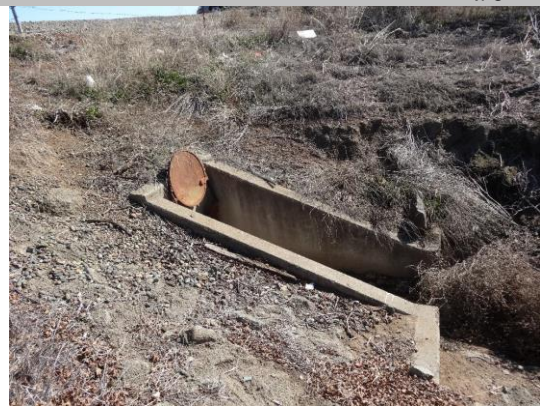
Photo 1 of 3 : UCIP_SP_2018_41375_56646.jpg

WS view: U type concrete headwall and flapgate on levee slope.
Vegetation debris on spillway.

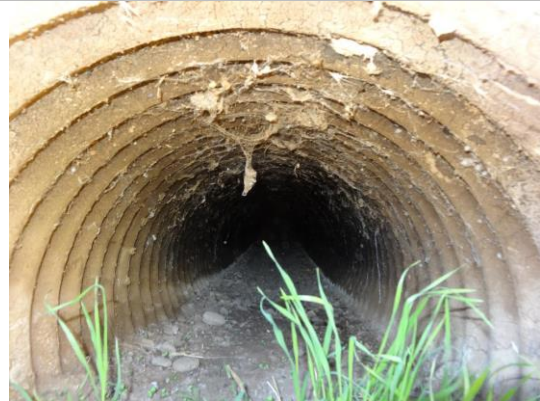
Photo 3 of 3 : UCIP_SP_2018_30763_56660.jpg

LS view: inside view of CMP on levee slope. Needs cleaning and clearing.

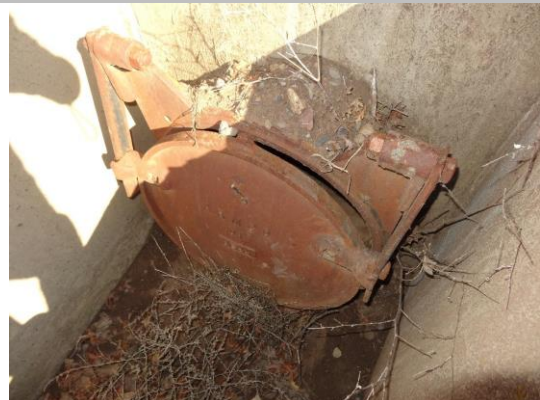
Photo 1 of 3 : UCIP_SP_2018_30783_56682.jpg

WS view: U type concrete headwall, pipe, and flapgate on levee slope. Gate not fully closed. Debris and soil in outlet box.

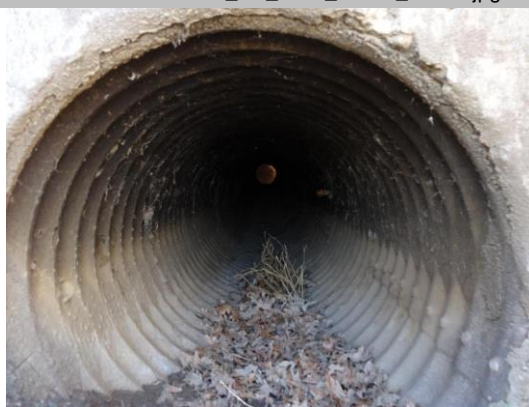
Photo 3 of 3 : UCIP_SP_2018_30783_56680.jpg

LS view: inside view of CMP on levee slope. Needs cleaning and clearing.

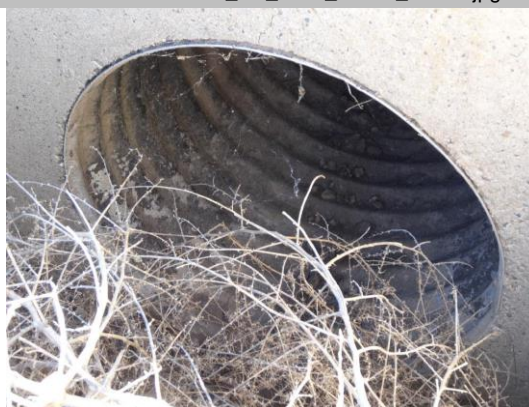
Photo 3 of 3 : UCIP_SP_2018_30803_56683.jpg

LS view: inside view of CMP on levee slope. Needs cleaning and clearing.

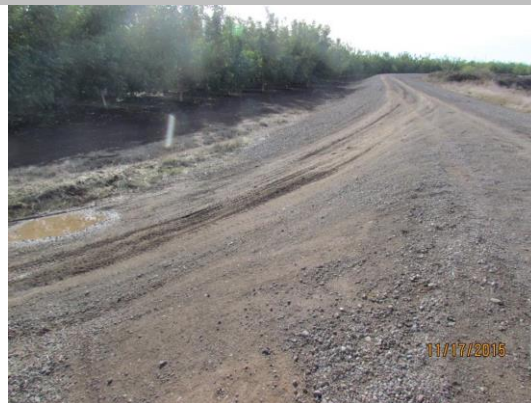
Photo 1 of 1 : SP_2018_NA0003_65_10_20180305_00007.jpg

View of the vehicle erosion along the landside slope.

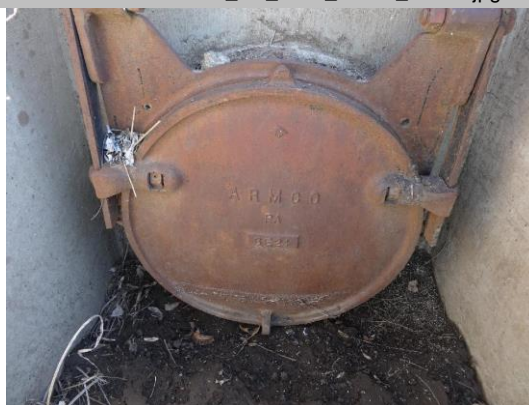
Photo 1 of 3 : UCIP_SP_2018_31028_56913.jpg

WS view: U type concrete headwall, pipe, and flapgate on levee slope.
Soil/mud on outlet box.

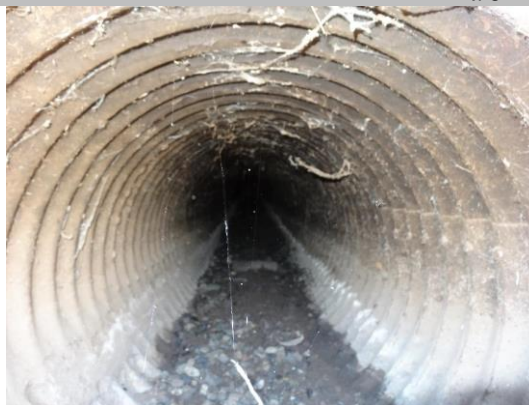
Photo 3 of 3 : UCIP_SP_2018_31028_56911.jpg

LS view: inside view of CMP on levee slope. Needs cleaning and clearing.

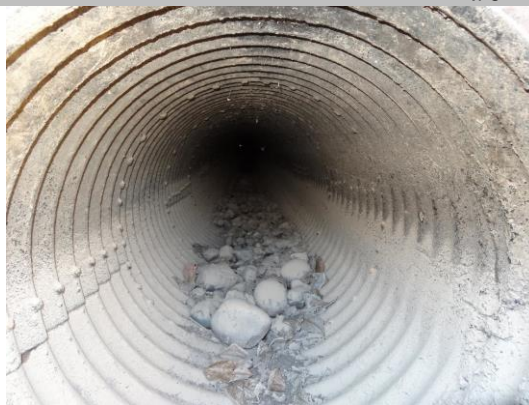
Photo 3 of 3 : UCIP_SP_2018_31085_56986.jpg

LS view: inside view of CMP on levee slope. Needs cleaning and clearing.

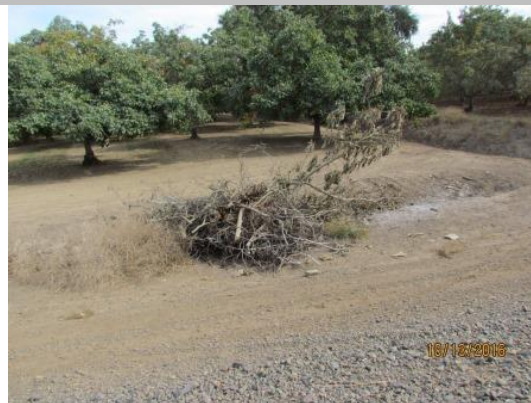
Photo 1 of 1 : SP_2018_NA0003_65_39_20180305_00016.jpg

View of the prunings along the landside toe.

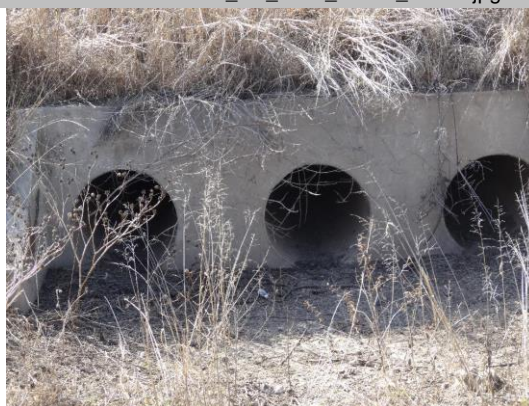
Photo 3 of 3 : UCIP_SP_2018_32085_58586.jpg

LS view: U type concrete headwall and CMPs on levee slope. Soil/mud on inlet box.

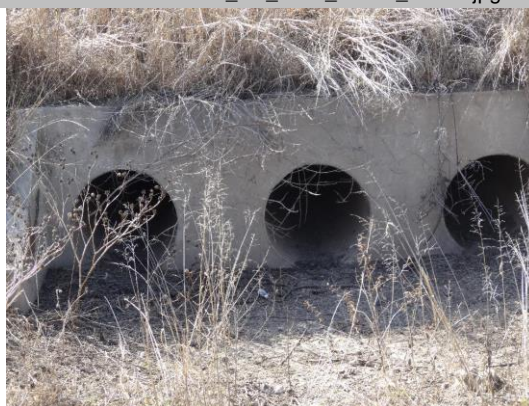
Photo 3 of 3 : UCIP_SP_2018_32086_58587.jpg

LS view: U type concrete headwall and CMPs on levee slope. Soil/mud on inlet box.

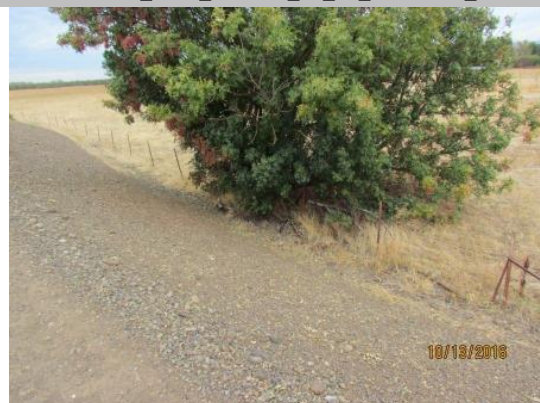
Photo 1 of 1 : SP_2018_NA0003_67_15_20180305_00004.jpg

View of the overgrown tree along the landside slope.

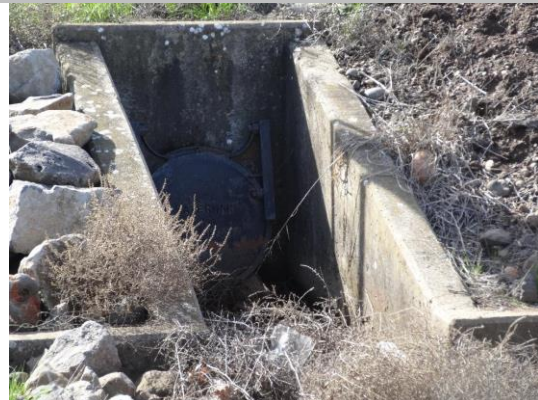
Photo 1 of 3 : UCIP_SP_2018_32124_58625.jpg

WS view: concrete headwall, pipe, and flapgate on levee slope.
Vegetation and mud on outlet box.

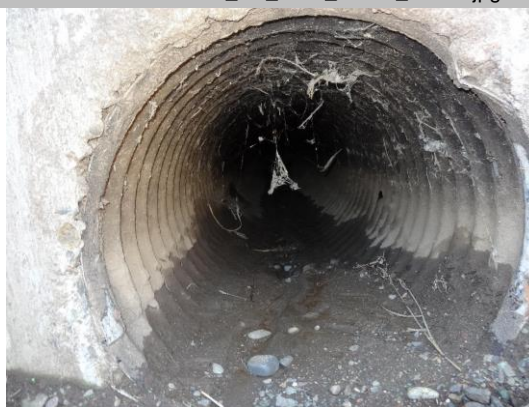
Photo 3 of 3 : UCIP_SP_2018_31901_58195.jpg

LS view: inside view of CMP on levee slope. Needs cleaning and clearing.

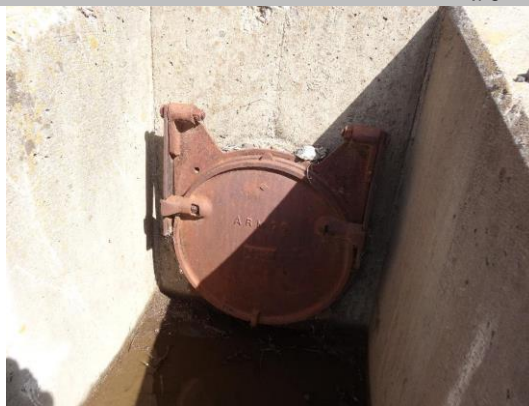
Photo 1 of 3 : UCIP_SP_2018_31856_58053.jpg

WS view: U type concrete headwall, pipe, and flapgate on levee slope.
 Soil/mud on outlet box.

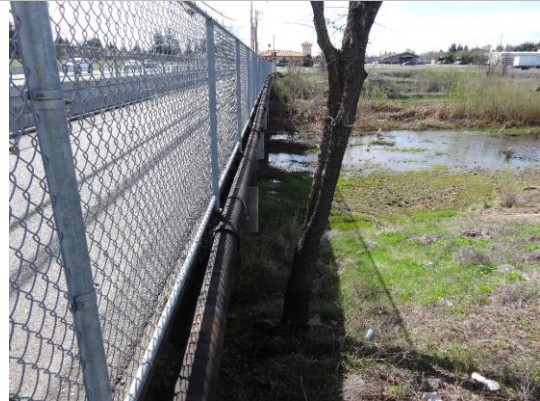
Photo 1 of 1 : UCIP_SP_2018_31851_58041.jpg

WS view: 6-inch steel pipe attached to Cohasset Road Bridge. Needs confirmation from LMA whether this is a gasoline.

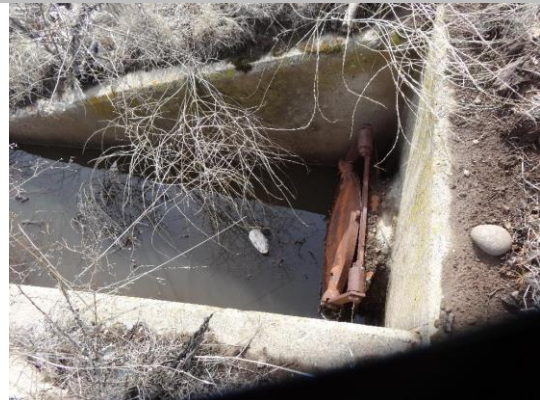
Photo 1 of 2 : UCIP_SP_2018_32125_58629.jpg

WS view: U type concrete headwall, pipe, and flapgate on levee slope. Soil/mud on outlet box. Vegetation debris blocking outlet box.

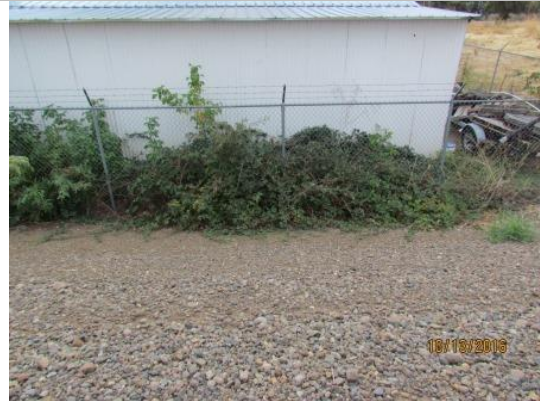
Photo 1 of 1 : SP_2018_NA0003_68_20_20180305_00006.jpg

View of the vegetation along the landside toe blocking visibility.

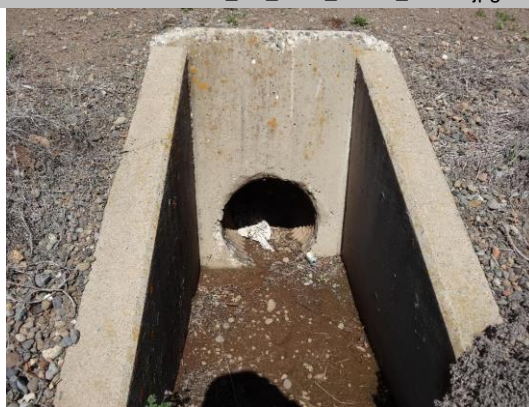
Photo 3 of 3 : UCIP_SP_2018_32026_58518.jpg

LS view: U type concrete headwall and CMP on levee slope. Mud and pebbles on inlet box.

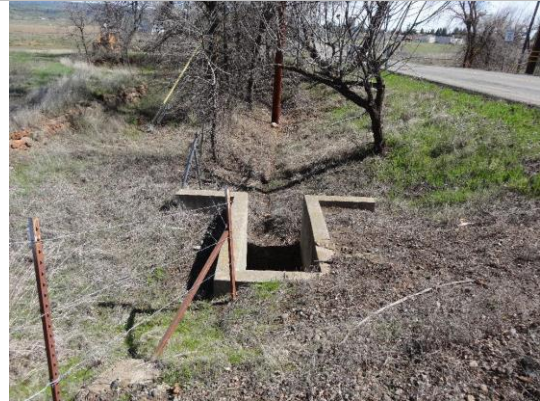
Photo 3 of 3 : UCIP_SP_2018_32025_58510.jpg

LS view: U type concrete headwall and CMP on levee slope. Vegetation debris and mud on inlet box.

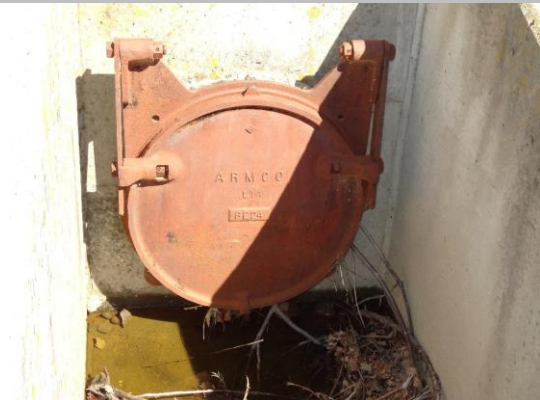
Photo 1 of 3 : UCIP_SP_2018_32023_58505.jpg

WS view: U type concrete headwall and CMP on levee slope. Vegetation debris and mud on outlet box. Needs cleaning and clearing.

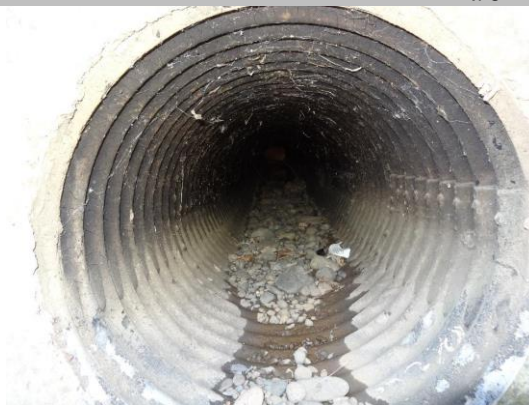
Photo 3 of 3 : UCIP_SP_2018_32023_58503.jpg

LS view: inside view of the CM pipe. Needs cleaning and clearing the pipe.

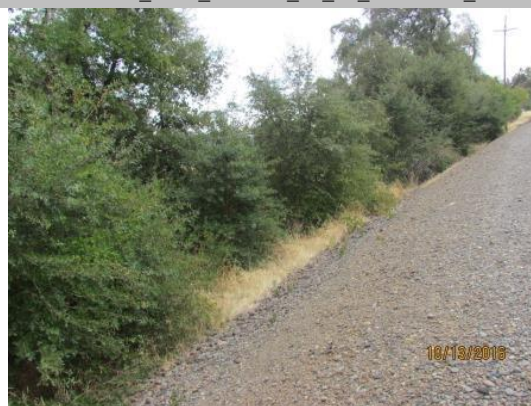
Photo 1 of 1 : SP_2018_NA0003_68_21_20180305_00007.jpg

View of the overgrown trees along the landside toe.

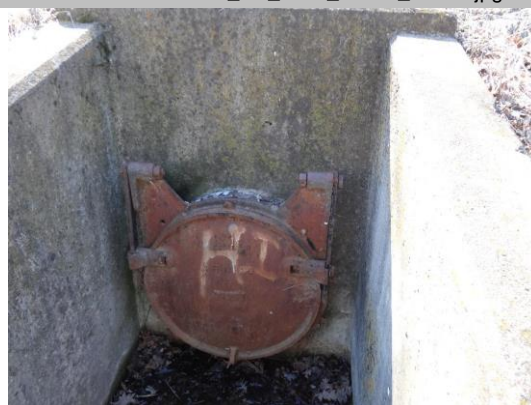
Photo 1 of 2 : UCIP_SP_2018_32143_58641.jpg

WS view: U type concrete headwall and CMP on levee slope. Soil/mud on outlet box. Needs cleaning and clearing.

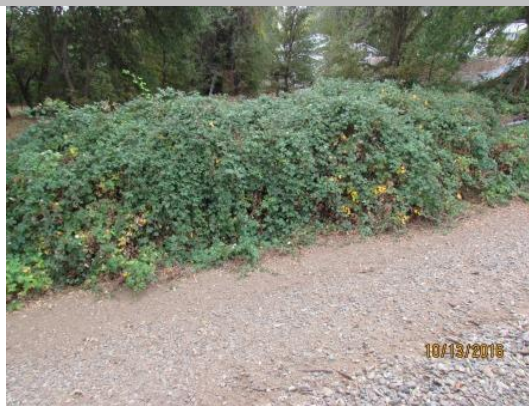
Photo 1 of 1 : SP_2018_NA0003_68_23_20180305_00009.jpg

View of the blackberries blocking visibility and access.

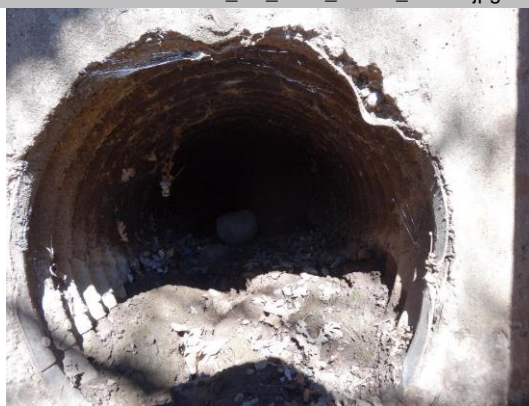
Photo 3 of 3 : UCIP_SP_2018_31963_58385.jpg

LS view: inside view of CMP on levee slope. Needs cleaning and clearing.

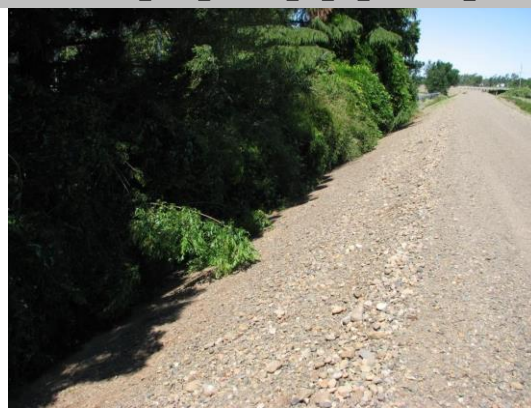
Photo 1 of 1 : SP_2018_NA0003_68_18_20180305_00005.jpg

View of the vegetation on fence at landside toe.

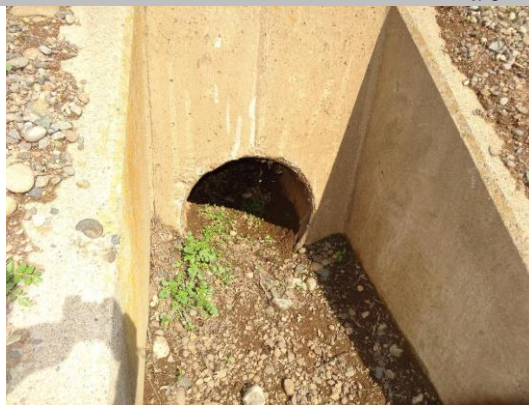
Photo 2 of 3 : UCIP_SP_2018_31965_58394.jpg

LS view: U type concrete headwall and CMP on levee slope. Vegetation debris and mud in inlet box.

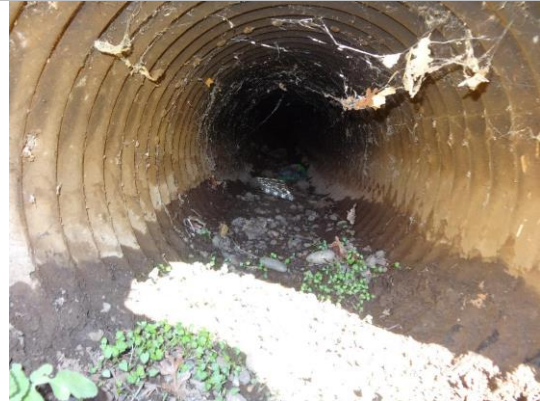
Photo 3 of 3 : UCIP_SP_2018_31965_58393.jpg

LS view: inside view of CMP on levee slope. Needs cleaning and clearing.

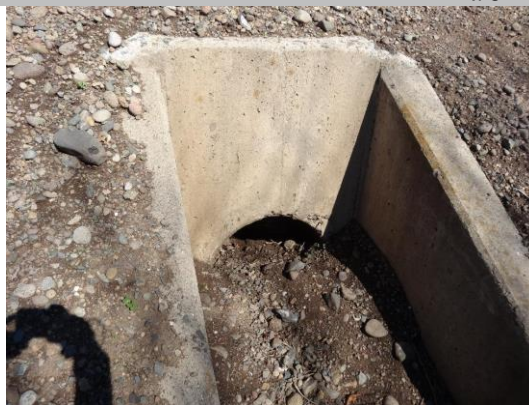
Photo 3 of 3 : UCIP_SP_2018_31966_58399.jpg

LS view: U type concrete headwall and CMP on levee slope. Vegetation debris and mud in pipe and inlet box.
